# MTS-Test Workmanship Standards

Workmanship Standards Number: 02-06

- 1.1 Name: Casting – Cast Aluminum – Smeared Material
- 1.2 Workmanship Standards Category: Metal Fabricated Materials
- 1.3 Purpose/Description (why/when/how): The existence of unacceptable smeared material creates risks to meeting cosmetic requirements of finished surfaces at subsequent operations.
- 1.4 Illustration: The following illustrations depict “Acceptable” and “Unacceptable” workmanship results.

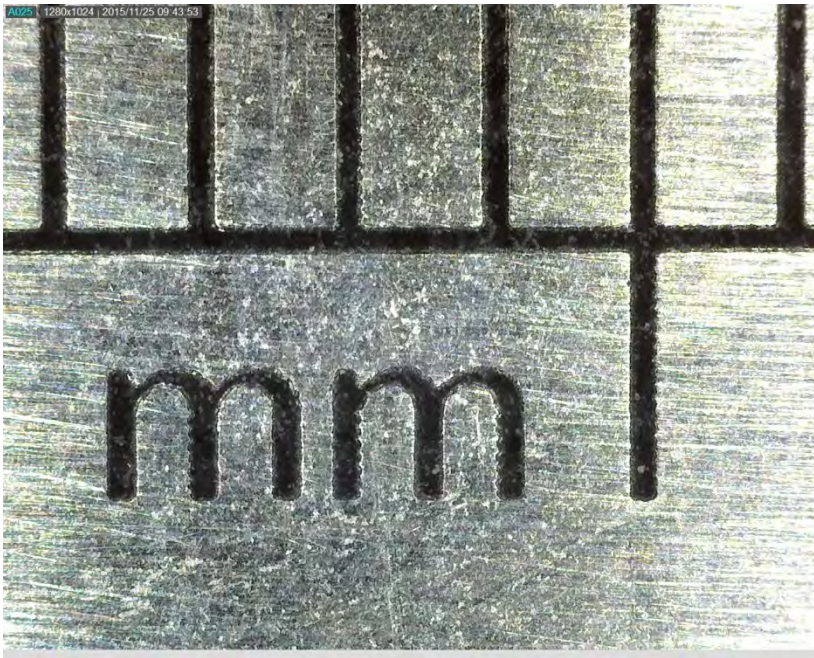
This image shows the resolution needed to achieve comparable reference images.

Picture taken at approximately 70x.

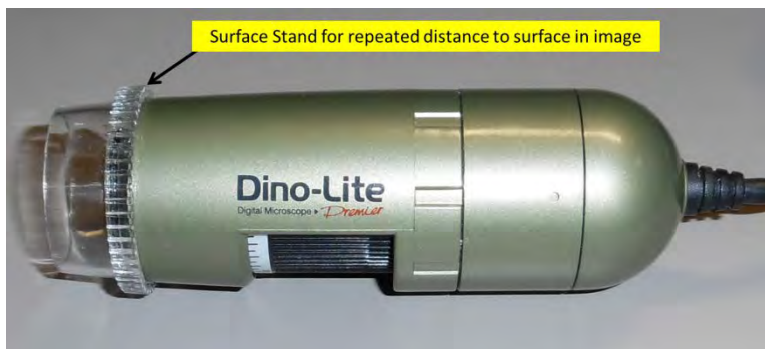
The use of a camera similar to that shown to the left is advantageous due to the plastic stand-off which controls the distance to the imaging surface.

A surface imaging microscope may be of equal use but may not provide for a permanent record.

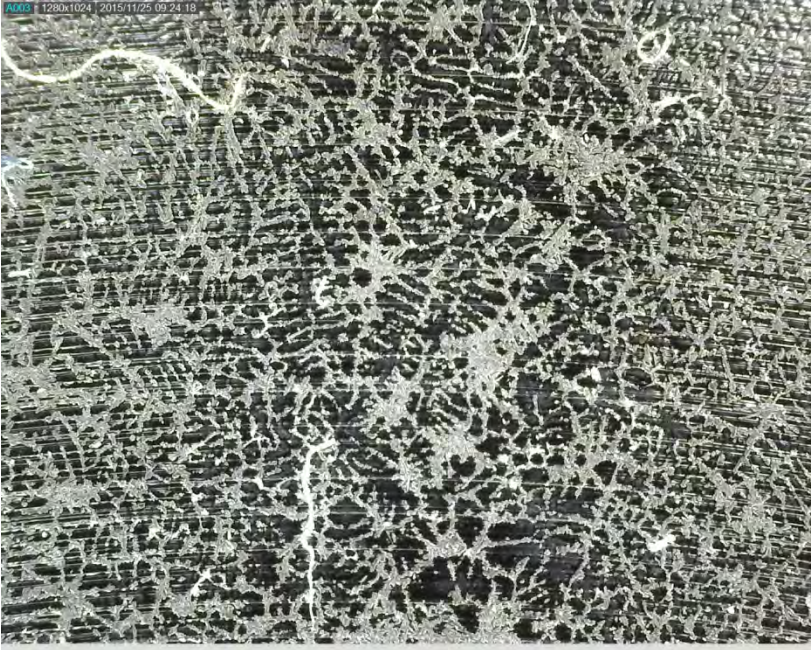
The image below shows the surface of an **acceptable** machined surface.

The machine tooling marks are evident as lines sweeping horizontally across the image. Minor artifacts of the material structure are visible indicating a clean surface of the material.

Picture taken at approximately 70x.

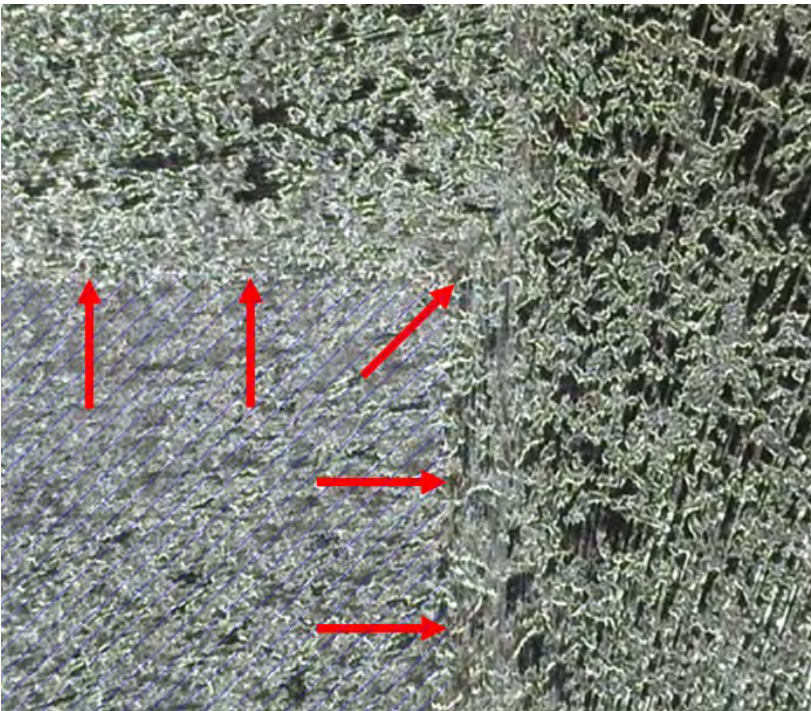
The image shows two areas of the machined surface of interest. One section in the lower left is annotated with blue diagonal lines and is meant to be excluded from consideration. The areas to the top and the right are areas of interest to compliment the image shown above.

Picture taken at approximately 70x.

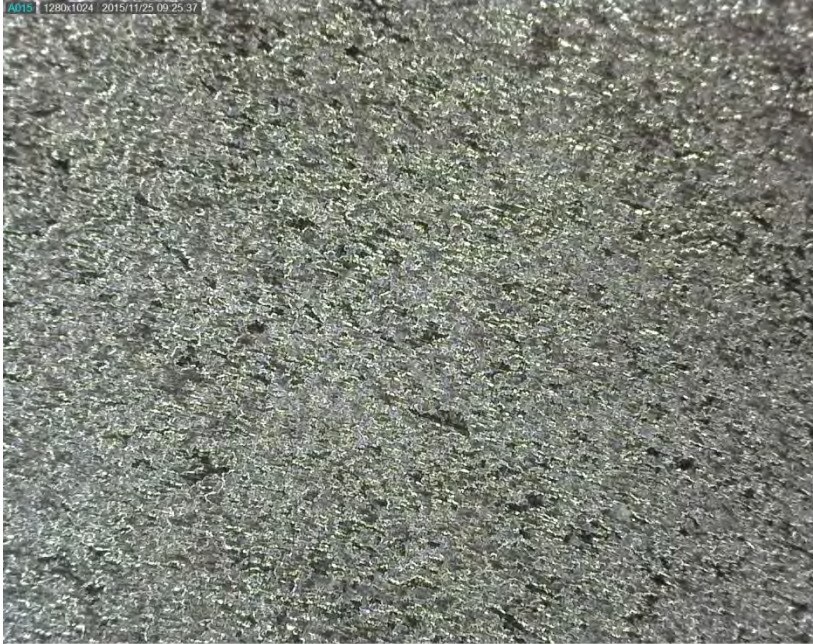
The image below shows the surface of an unacceptable machined surface.

This surface was found to be unacceptable due to the smeared metal. Additional image shown below for further reference.

Picture taken at approximately 70x.

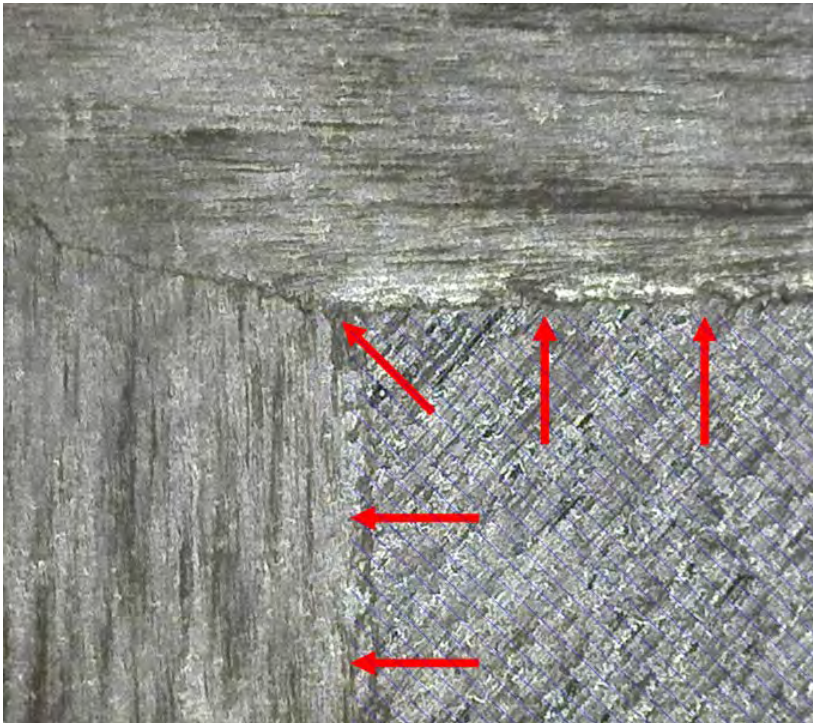
The image shows two areas of the machined surface of interest. One section in the lower right is annotated with blue diagonal lines and is meant to be excluded from consideration. The areas to the top and the left are areas of interest to complement the image shown above.

Picture taken at approximately 70x.
